# Manhole Inspection Summary

Manhole # S27I\_\_031MH

Insp Date: **5/28/08 2:05 PM**

**Location** Address: **36 S Schroeder St**

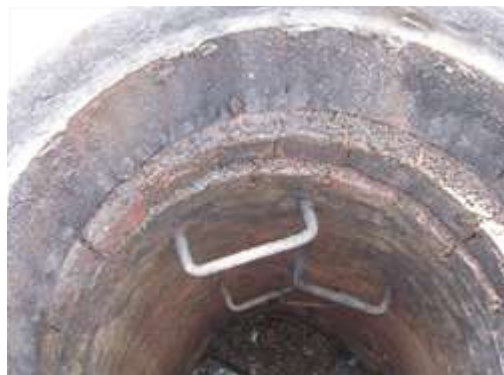
Defect 3

Condition: ☐ Sound ☐ Cracked ☒ **Leaks**

Infiltration: ☐ None ☒ **Joint** ☐ Cracks ☒ **Mortar** ☐ Roots ☐ Wall

infiltration from lid frame as well as gap between frame and chimney

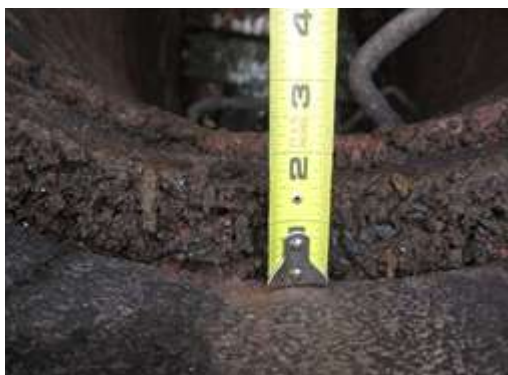
Defect 4

Offset: **1.5** (in.)

Frame offset 1.5

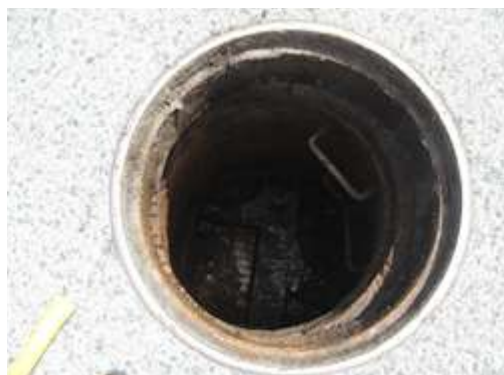
Defect 5

offset and frame leaks

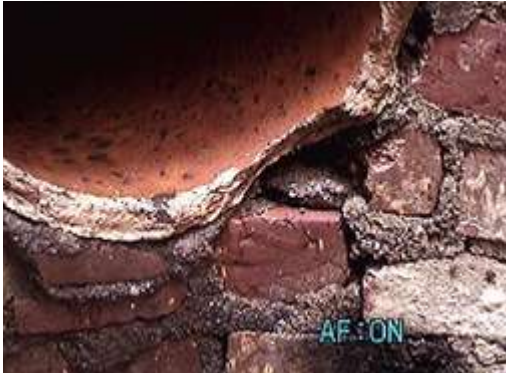
Defect 2

Infiltration: ☐ None ☐ Joint ☐ Cracks ☐ Mortar ☐ Roots ☒ **Wall**

missing mortar, infiltration in barrel at 4 o'clock pipe

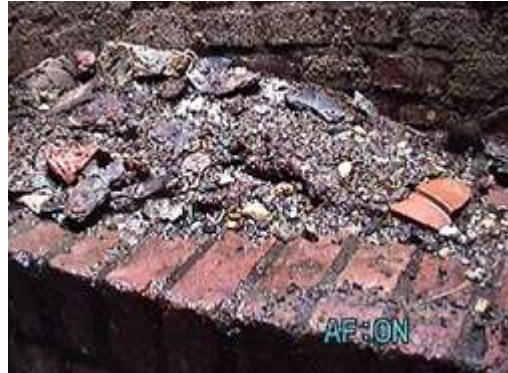
Defect 1

Condition: ☐ Sound ☐ Cracked ☐ Root Intrusion ☐ Deteriorated ☐ Leaks ☒ **Debris**

debris on bench

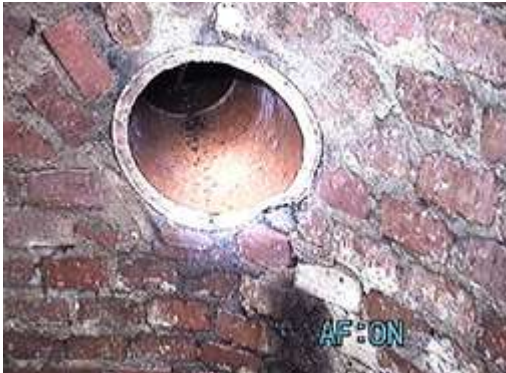
Defect 6

Condition: ☐ Sound ☒ **Cracked** ☐ Root Intrusion ☐ Loose Brick ☐ Deteriorated

cracked barrel

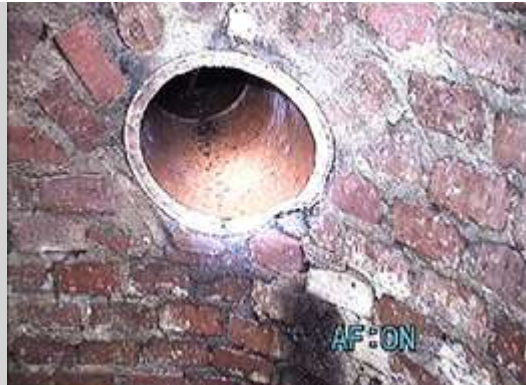
Defect 6

cracked barrel
